Learning from Structural Disasters

*Doctor's mistakes are buried,
but Engineer's mistakes become monuments*

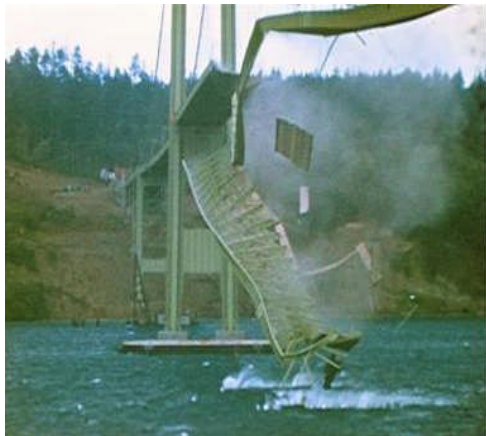
TACOMA WASHINGTON BRIDGE DISASTER

The Tacoma Narrows Bridge is a pair of mile-long (1600 meter) suspension bridges with main spans of 2800 feet (850 m). The first bridge, nicknamed *Galloping Gertie*, was opened to traffic on July 1, 1940, and became famous four months later for a dramatic wind-induced structural collapse that was caught on color motion picture film

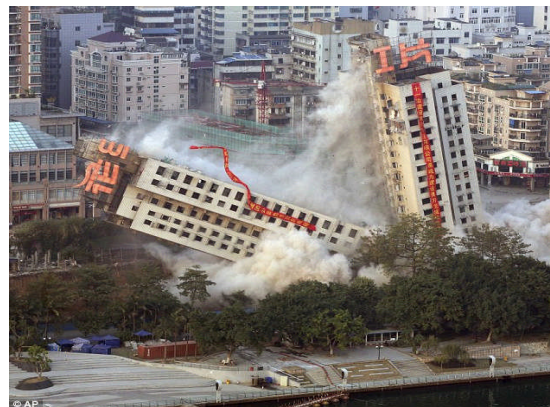
APARTMENT BUILDING SPLITS INTO TWO,
FALLS SIDEWISE

It happened in the city of Liuzhou, China. Instead of collapsing straight down, the 22 story apartment building splits into two halves, with one half falling to the ground sideways (fortunately not causing a disaster or taking any lives) and the other half remaining standing on an angle that makes it look like the Leaning Apartment Tower of China

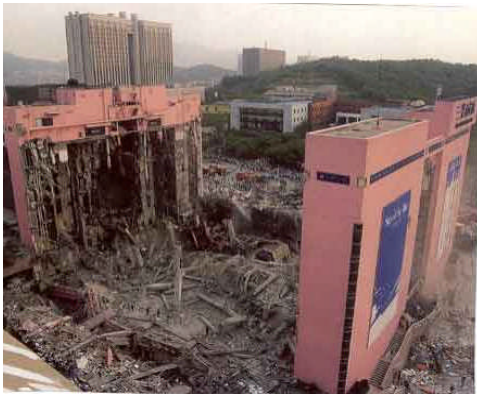
THE SAMPOONG DEPARTMENT STORE

The Sampoong Department store collapse killed 500 people. The building was originally planned as a 4 story office building. Then it was changed to be a department store, which entailed removing a portion of the structure to make room for escalators and an atrium. In addition, a 5th floor was later added, and the HVAC equipment was moved onto the new roof, severely overloading the structure.

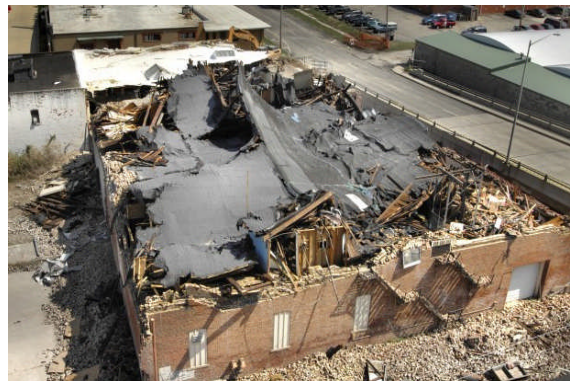
WAREHOUSE AT BLOOMINGTON

A century old, three storey brick building at 317 S. Center St. collapsed, spilling rubble onto the center street bridge.

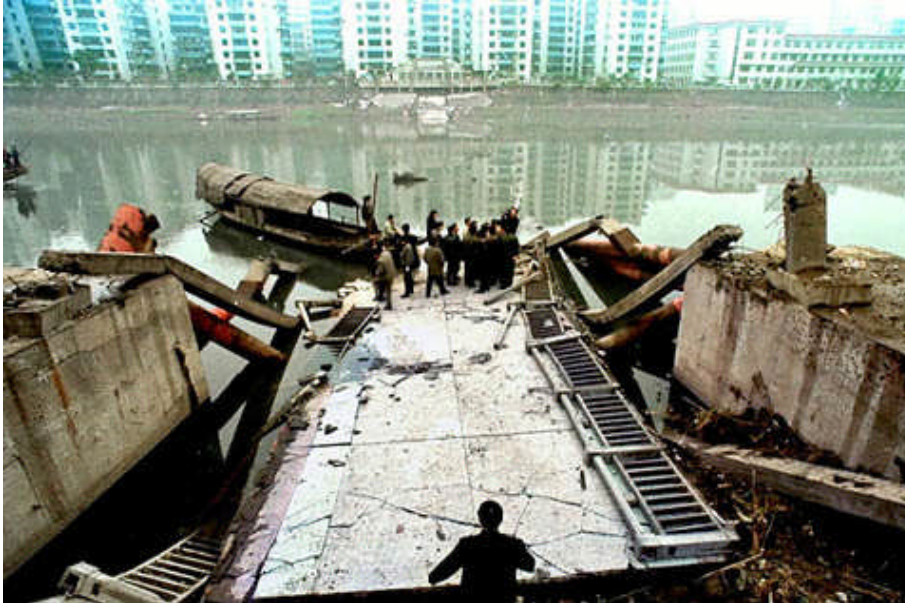
RAINBOW BRIDGE, CHINA

In January 4, 1999, a pedestrian Rainbow bridge across the Qi River in the Sichuan province collapsed three years after it was built. The collapse of the Rainbow bridge led to 40 deaths and 14 injuries. Parts of the bridge were rusty, concrete used in its construction was too weak and there were serious welding problems.

- ❖ *A qualified structural Engineer/organization should be assigned to do the structural design.*
- ❖ *All the possible loads coming on the structure should be visualized and all the possible load combinations shall be applied while designing.*
- ❖ *A structural Engineer shall also consider the practical feasibility of the design.*
- ❖ *Preparation of the design document should be given priority.*
- ❖ *Structural designs should be proof checked by experienced structural engineers.*

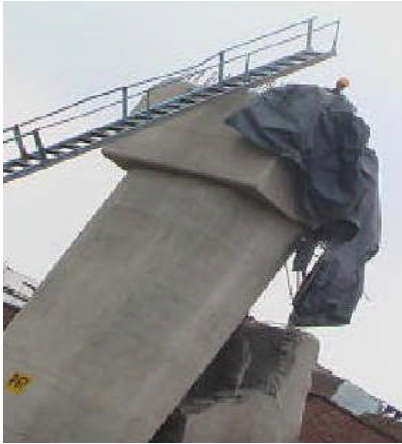
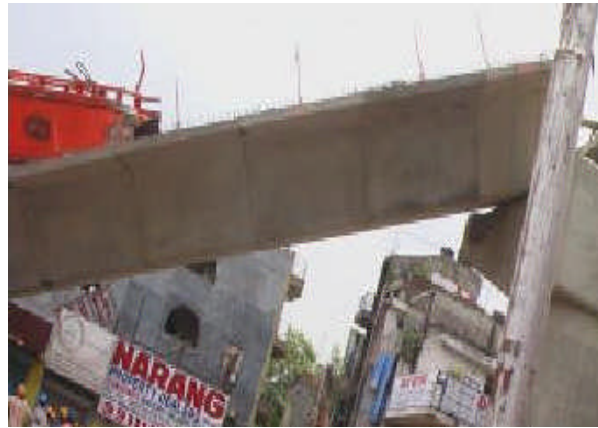
METRO RAIL BRIDGE, INDIA

The failure of pier cap occurred due to inadequate prop / jacket. This was coupled with failure of cantilever pier cap due to inadequate development length of top reinforcement of the cantilever pier cap.

The cantilever pier cap which was behaving as a simply supported beam due to introduction of prop / jacket started behaving like a cantilever beam suddenly after failure of the prop which it cannot sustain (It was inadequately designed). So, the so called "cantilever pier cap" collapsed.

- ❖ *Reinforcement detailing should be given more emphasis considering the behavior of structural components and connections between components.*
- ❖ *Ductile detailing in the seismic areas should be given emphasis.*
- ❖ *Detailing of corbels, deep beams, cantilevers etc should be checked as per the codal provisions.*
- ❖ *Planning of the construction phases should be given importance.*
- ❖ *Deploying adequately experienced Engineer/ Supervisor for construction/erection supervision.*
- ❖ *Once construction is over, it is very important to prepare As-built drawings, the structural Engineer can refer to it in future, while making planning for extension etc.*

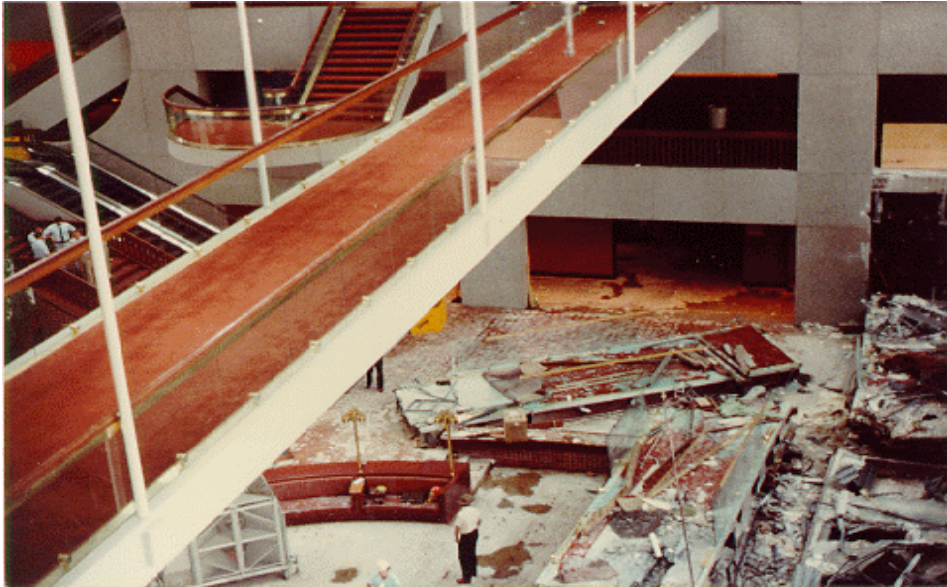
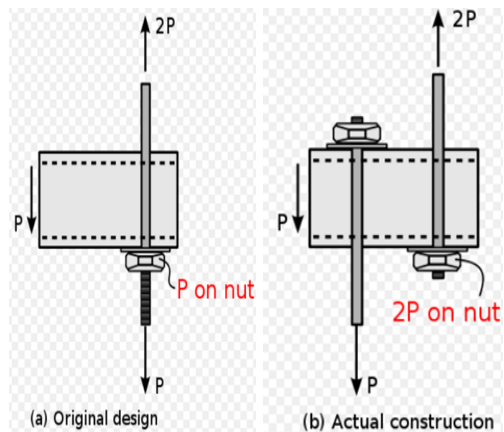
HYATT REGENCY WALKWAY COLLAPSE

The Hyatt Regency hotel walkway collapse was a collapse of a walkway that occurred on July 17, 1981, in Kansas City, Missouri, United States, killing 114 people and injuring 216 others during a tea dance. At the time, it was the deadliest structural collapse in U.S. history.

One of the defining features of the hotel was its lobby, which featured a multistory atrium spanned by steel, glass and concrete walkways on the second, third and fourth levels suspended from the ceiling. The walkways were approximately 120 ft (37 m) long and weighed approximately 64,000 lb (29,000 kg). The fourth level walkway aligned directly above the second level walkway.

The fourth floor bridge was suspended directly over the

- ❖ *Preparation of structural steel shop drawings should be done by a qualified person rather than the fabricator doing it himself.*
- ❖ *Deviations if any from the original design shall be approved by the designer.*
- ❖ *Well designed connection details are very important.*
- ❖ *Erection shall be based on a well planned erection methodology.*

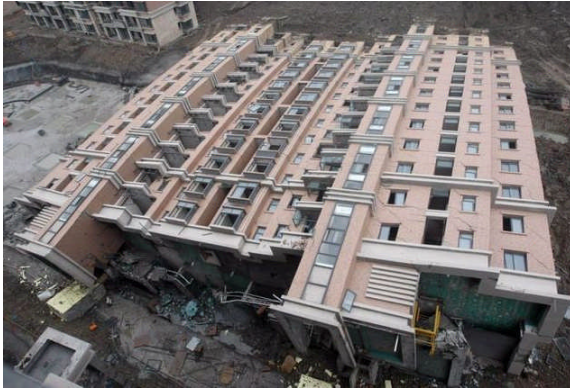
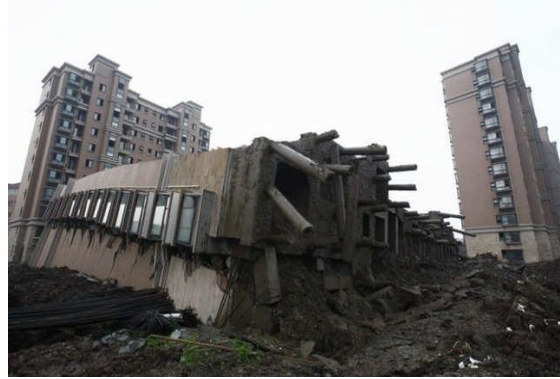
SHANGHAI APARTMENT COLLAPSE

13-storey apartment building collapsed in Chinese city of Shanghai, which was almost finished. It fell without being destroyed, like a domino. It gives the impression as if the building was razed as a tree and was laid down. According to the official version, the reason of the building collapsing was the construction of the underground garage and the loose soil.

The main reason for failure is a tall pile of dirt next to the building. The dirt excavated for the garage compacted the soil, causing it to shift and damage the building's foundations so that it fell over. Heavy rains and cracks in a flood wall for a nearby river also suggest problems with the soil on the site

- ❖ *A proper study of the soil investigation report should be done before designing.*
- ❖ *Before excavating close to an existing structure, strength of the soil and other properties shall be studied. Retaining structures should be designed and installed for retaining earth. The activity planning has a vital role.*

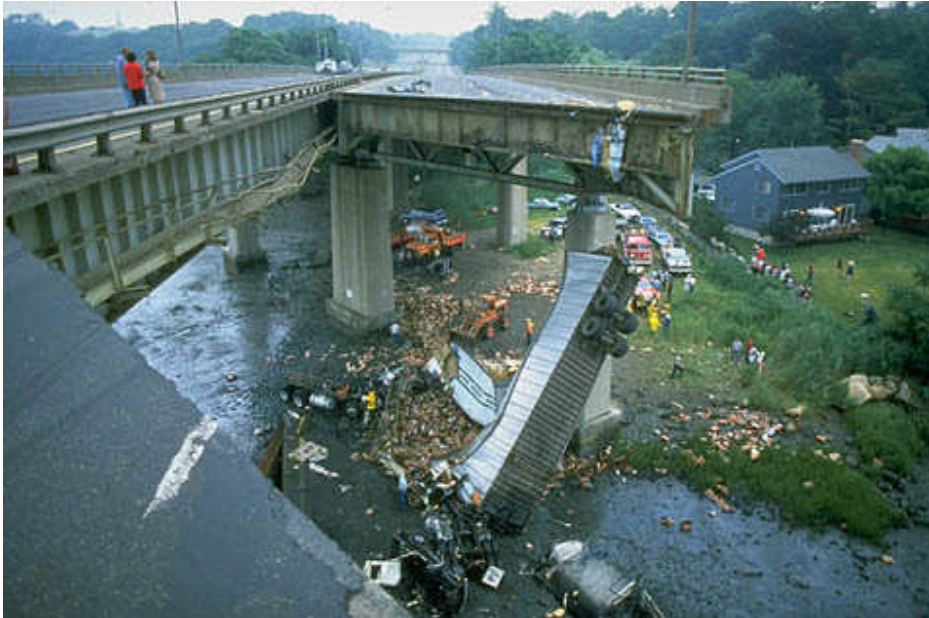
MIANUS RIVER BRIDGE ,USA

Three people were killed when their vehicles fell with the bridge into the Mianus River 70 feet below, and three were seriously injured. Collapse due to failure of the Pin and Hanger assembly supporting the span.

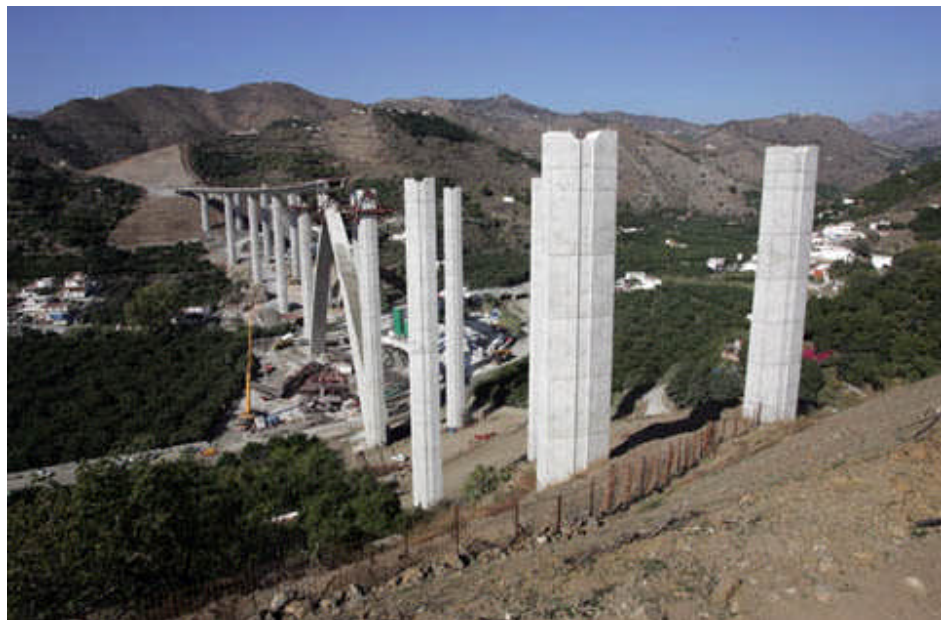
ALMUNECAR ,SPAIN

Five Portuguese and one Spanish national died near Almunecar on Spain's, after a 20-ton section of motorway viaduct fell from 80 meters onto workers below.
